“COMMERCIAL” DUE DILIGENCE INSPECTION REPORT

August 14, 2015

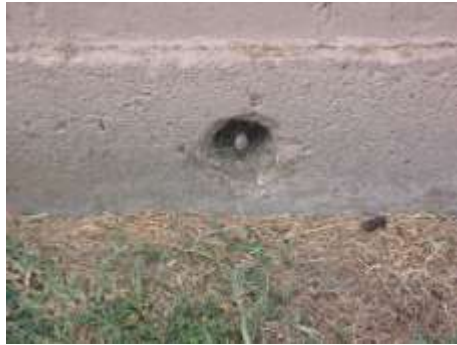
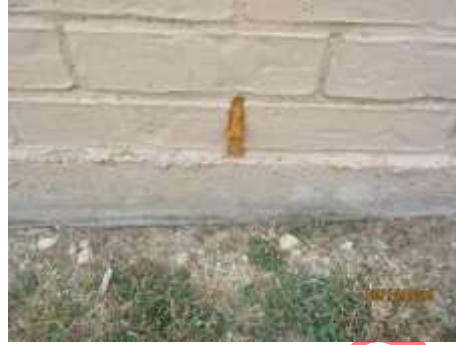
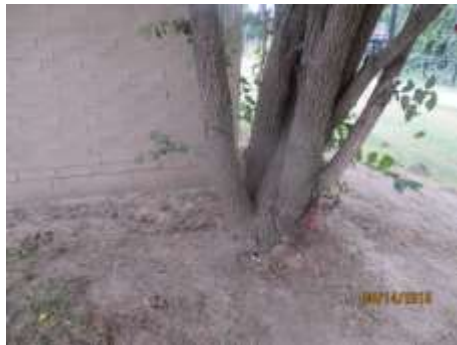
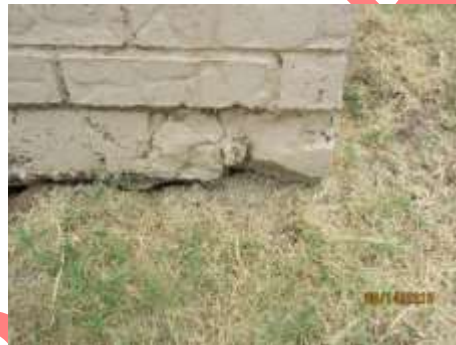
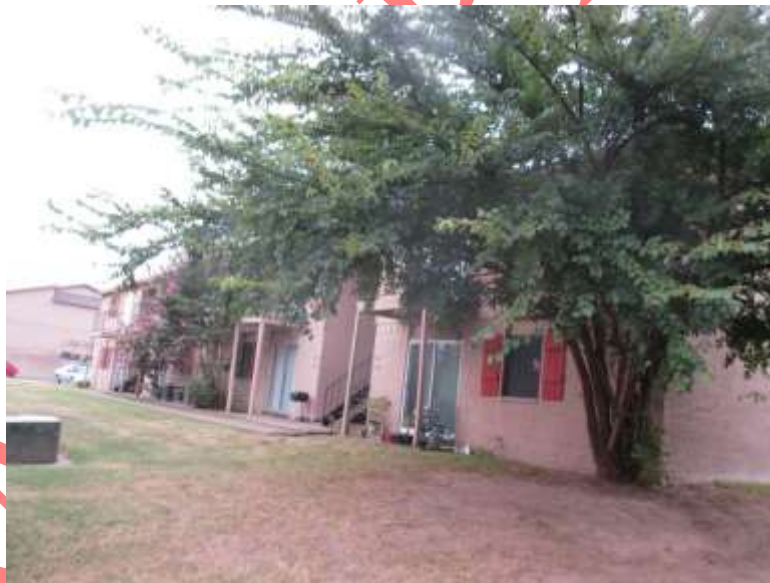
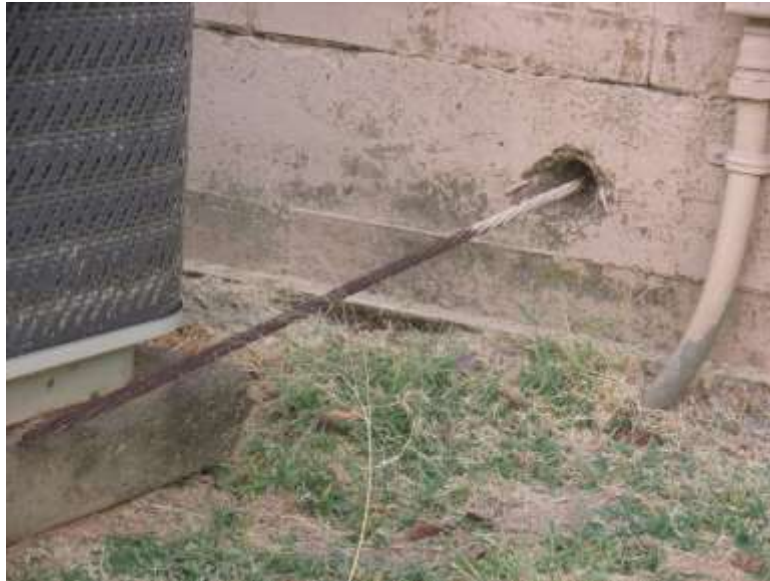
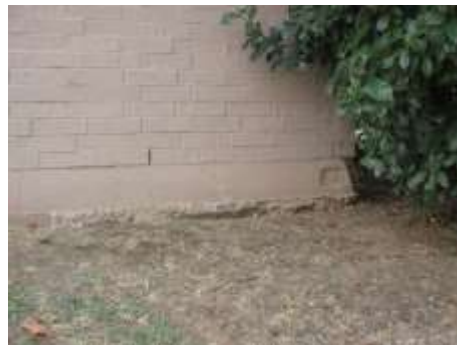
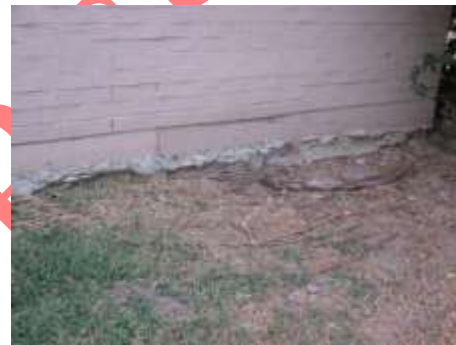
The foundation has signs of movement as evidenced by sheetrock cracks, slope on floors, sticking and/or non-latching doors, exterior crack or separations in the brick or brick mortar, separations of materials such as window frames and/or wood trim at Buildings 9, 10 and 11.

There are minor surface cracks visible at the exterior foundation wall at Buildings 9, 10 and 11.

The footers are exposed at the exterior foundation wall at Buildings 9, 10 and 11.

The slab corner(s) are cracked at most of the buildings. These cracks are not structurally significant.

There are signs of previous repairs visible at the exterior foundation wall at Buildings 9,10 and 11; it is my recommendation that you consult with the seller to determine what repairs have been made.

The soil line is pulling away from the foundation wall at all of the buildings; it is my recommendation that you install soaker hoses on a timer to ensure proper moisture content around the foundation and/or get the Irrigation System up and running to ensure that proper moisture content is present around the foundation walls.

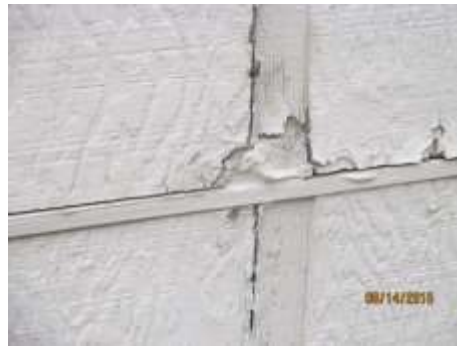
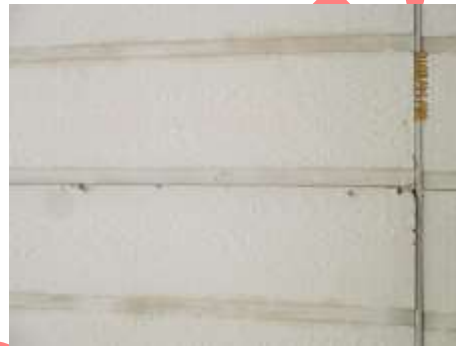
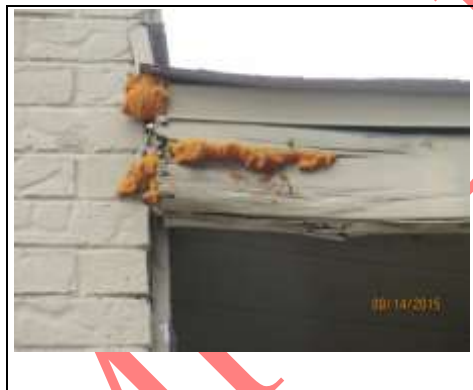
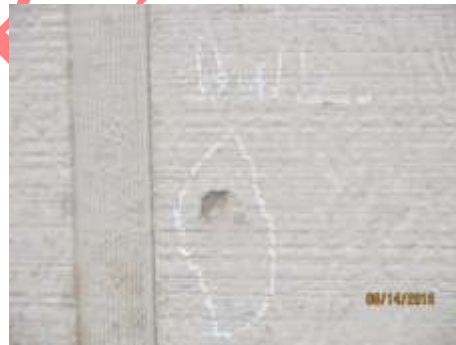
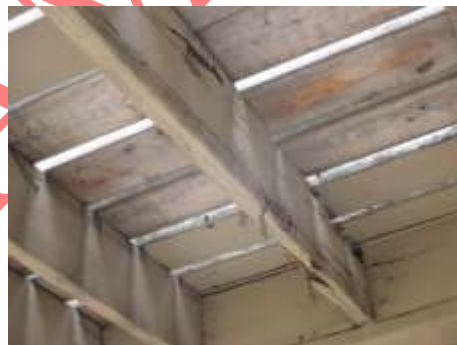
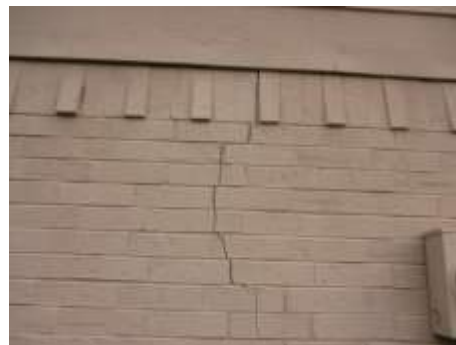
Wood rot is present at no less than 80% of the exterior walls at the soffits, fascia areas, siding and/or trim pieces.

There are some areas where the siding is damaged, front left side, back left side and upper gable areas at all of the structures.

There are signs of extensive termite damage present and some exterior walls and/or most of the damaged patio/deck areas.

There are excessive openings at some exterior masonry and siding walls with signs of significant hail damage present at the siding wall areas.

Some exterior siding pieces need to be sealed at the seams to prevent additional damage and/or wood rot.

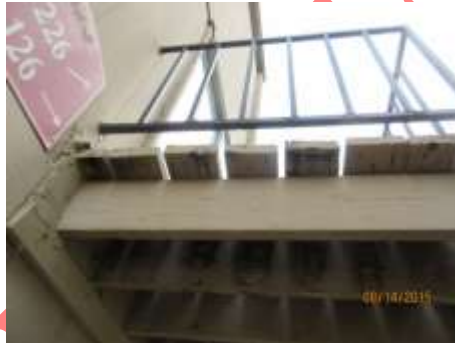
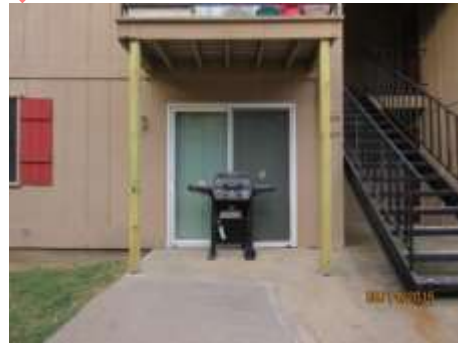
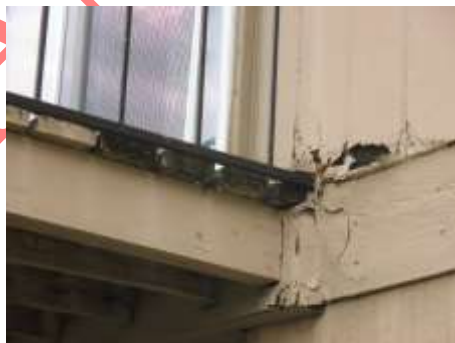
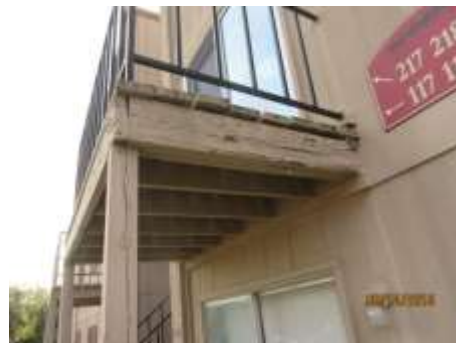
Several of the exterior plastic trim pieces on the windows have damaged areas.

The exterior steel stairs is rusting and needs to be wire brushed, primed and painted to prevent further damage at all (11) of the building.

Only (2) of the balconies appear to have recently been replaced and the remainder are in dire need of replacement to ensure that there are no safety concerns present.

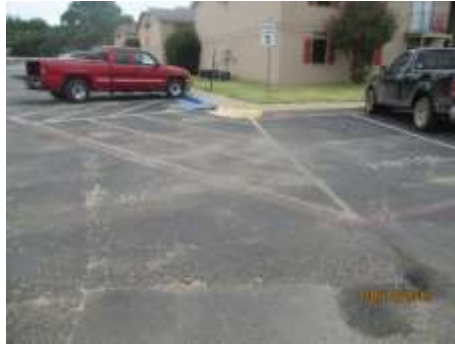
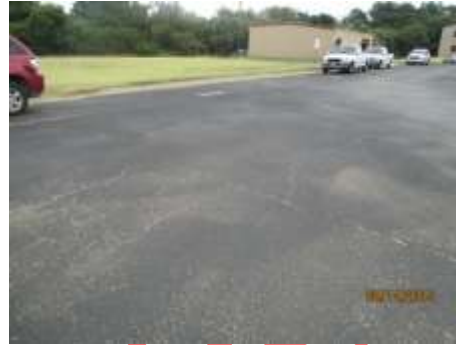
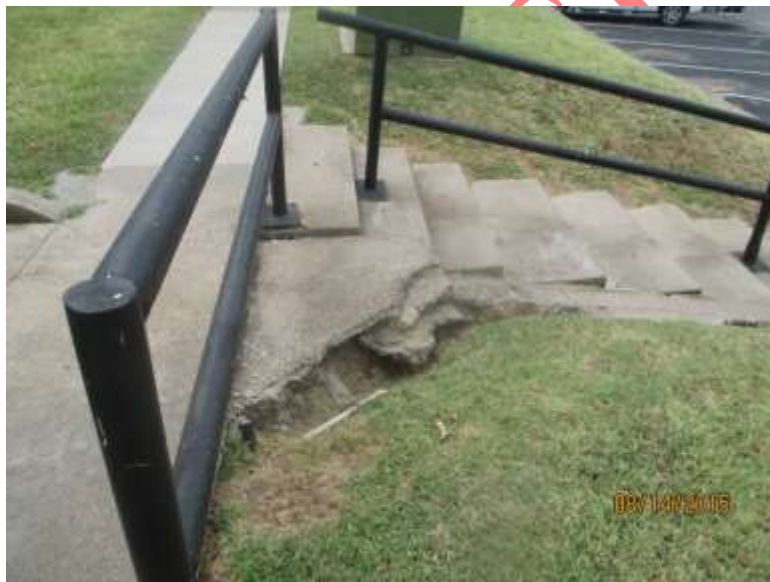
Some minor and major cracks are visible at some areas of the sidewalks and/or drive areas.

Immediate attention is needed at the sidewalk and/or common area between Buildings 9 and 10. Significant erosion is present and the deficiency poses a HIGH RISK FOR SAFETY CONCERN for tenants and visitors.

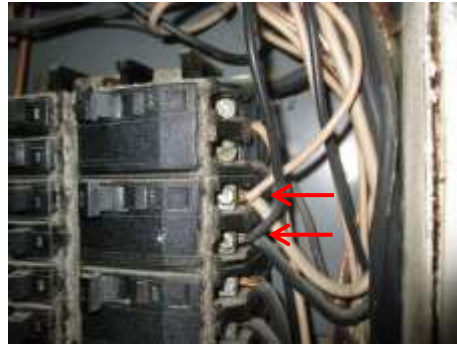
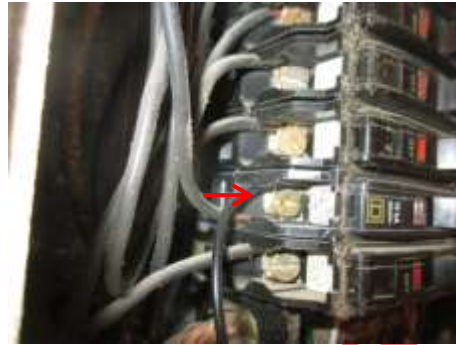
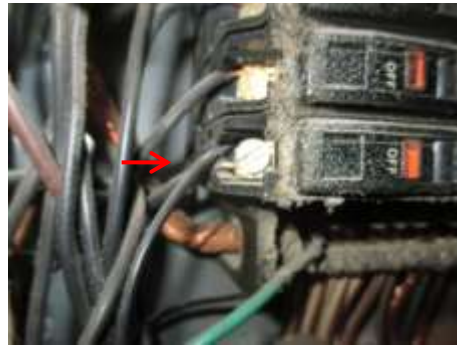
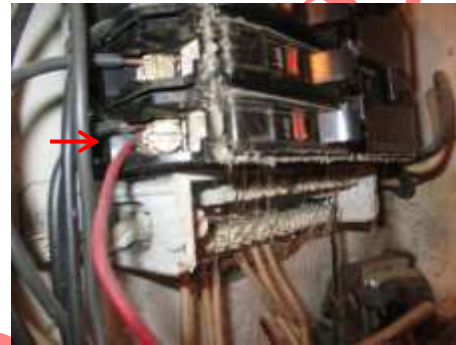
Plastic knock-outs are missing at the interior cover, see Individual Unit Breakdown or locations.

The panel box is installed at what is considered to be a hazardous location. New installation guidelines do not allow installations in clothes closets.

Considering the large number of double lugged breakers that were observed at the limited interior inspections of (22) units, it is my recommendation that you have all of the breaker boxes inspected by a qualified Electrician to determine the extent of deficiencies present.
