PROPERTY INSPECTION REPORT

New Construction

I. STRUCTURAL SYSTEMS

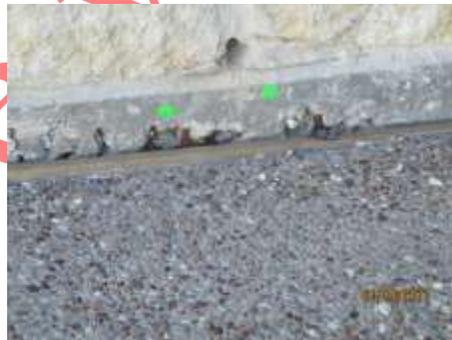
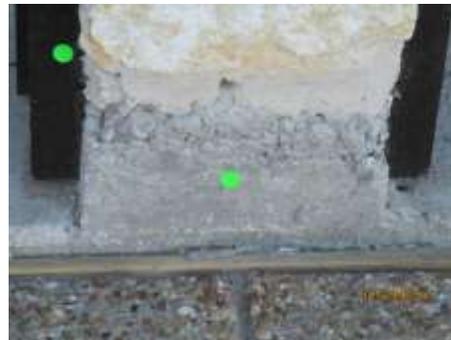
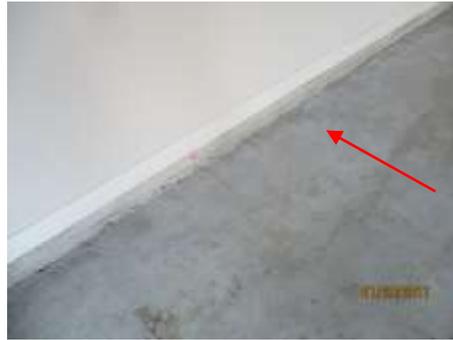
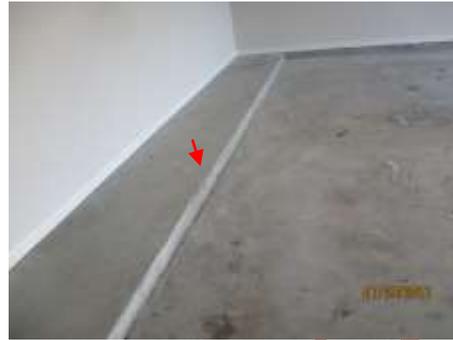
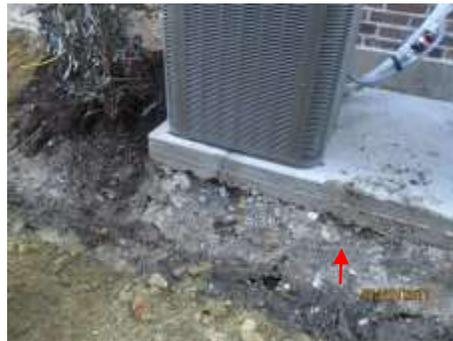
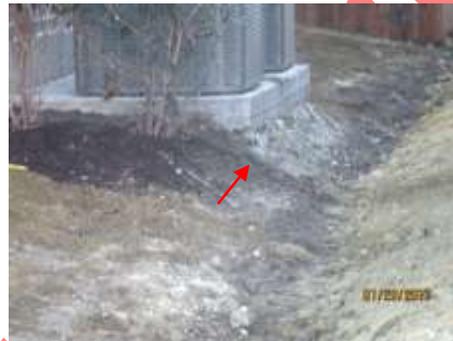
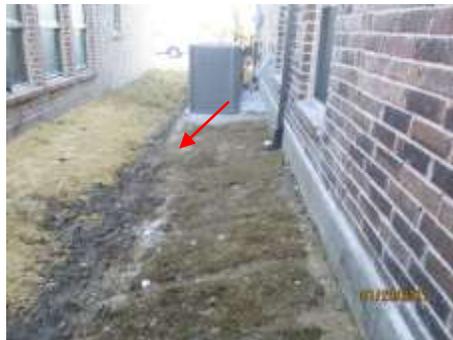
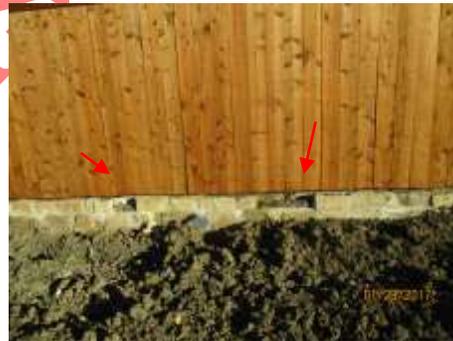
One area of the exterior foundation wall has signs of spalling at the front driveway, between both garages.

There are two missing stones at the back retaining wall.

The sod is excessively wet and/or dead at the right side of the structure.

One post tension cable needs to be trimmed and covered at the front driveway/sidewalk area.

The drainage is deficient at the left side of the structure with visible erosion present at the a/c pad. That area of the grade has standing water and may require a French drain to ensure that water is properly routed away from the swale area between the two structures.

There are rough areas and/or damaged spots at the interior garage floor.

The right side grade area may not have enough sunlight for sod to be able to grow. If this is the case, you may want to consider installing some type of gravel, river rock and/or drainage component to ensure that even moisture content is maintained around all sides of the structure.

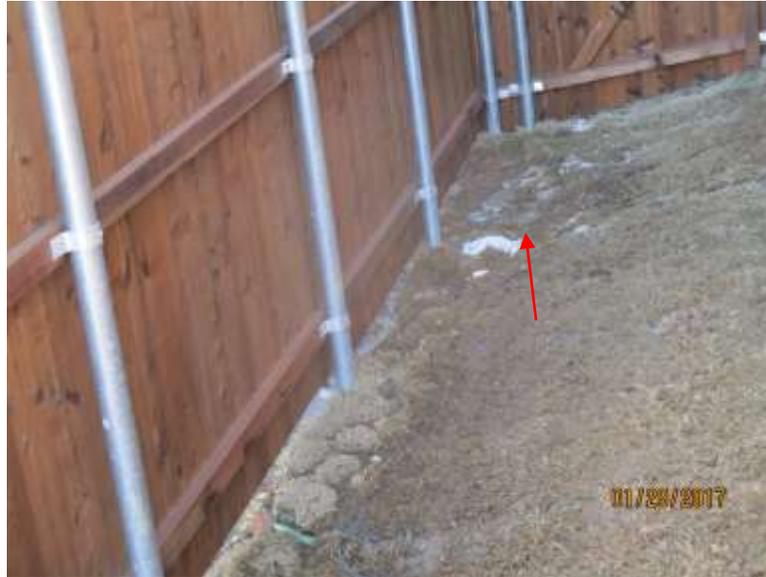
There is standing water along the right and back right sides of the structure. I am unable to verify if the swale is properly graded to ensure proper water runoff.

The sod is planted higher than the back right fence. This can prevent water from running away from the property and/or cause the fence picket to rot with excessive moisture.

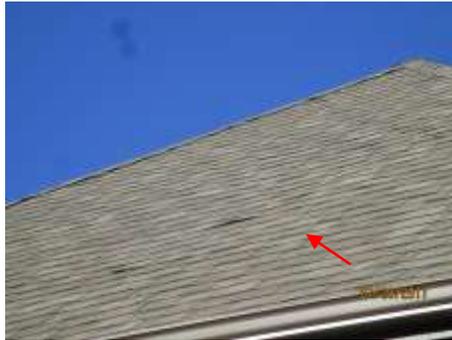
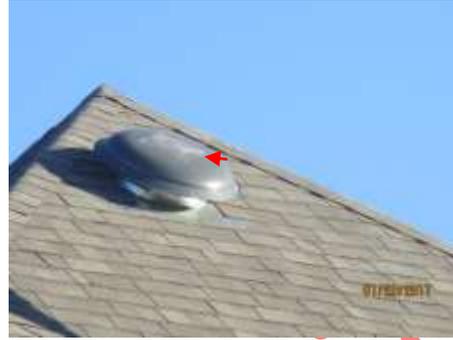
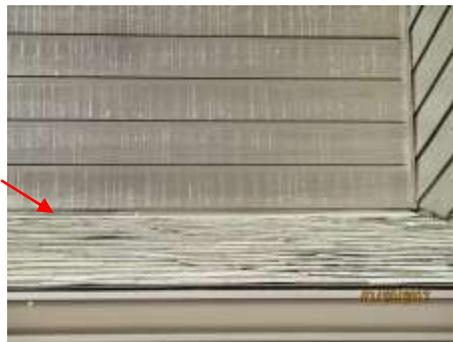
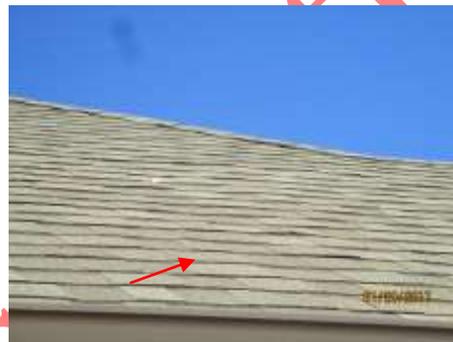
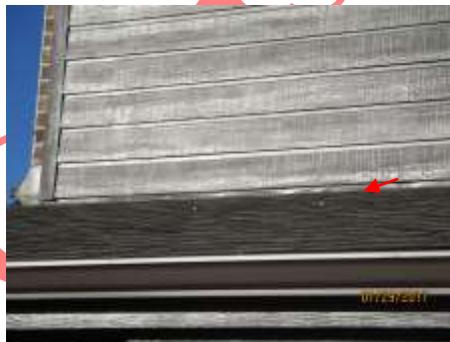
There are construction nails lying on the rooftop at a couple of locations.

There are nail lifted shingles present at the front entry, back and left sides of the structure.

There looks to be a piece of plastic and/or damaged area at the back static vent.

It is my recommendation that you have all of the nail lifted shingles properly secured and all of the nails and/or construction debris that is lying on the rooftop removed.

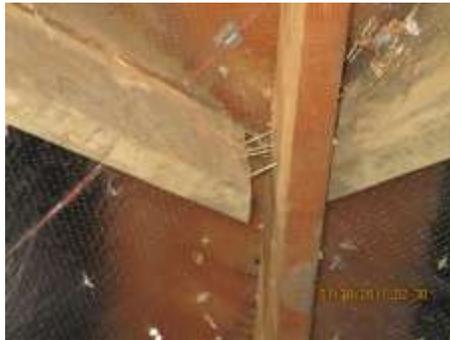
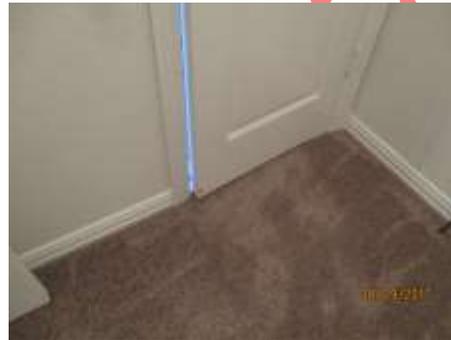
The upper media room walkout attic area has a door that drags on the threshold.

There is an area of the upper left walkout that needs a landing area for safety purposes.

One of the framing members is not properly secured at the upper left walkout area.

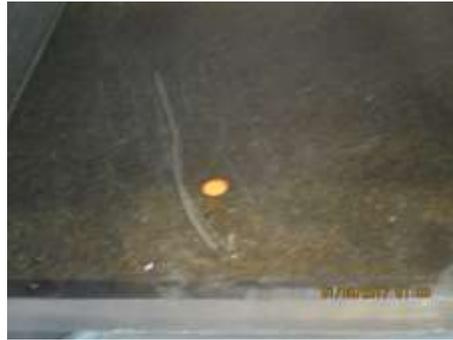
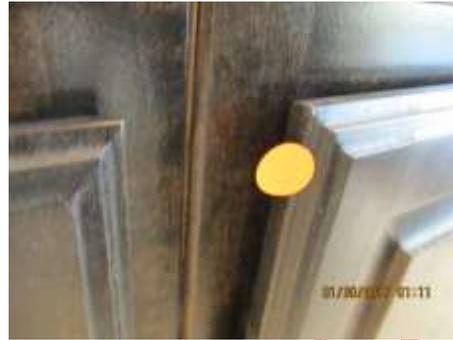
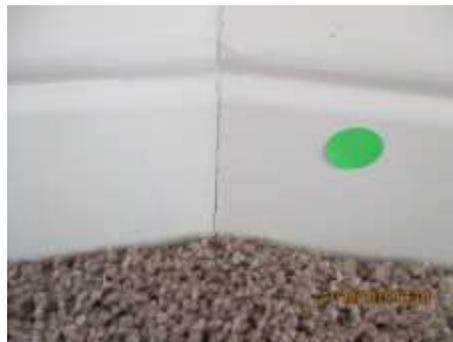
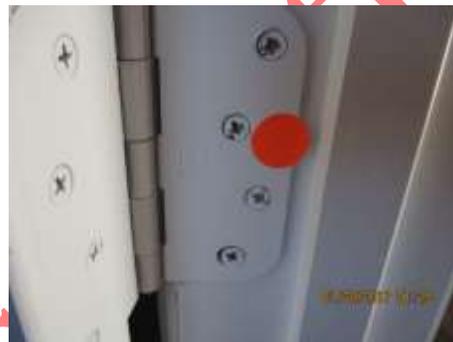
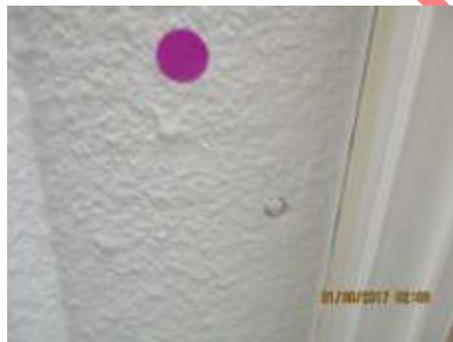
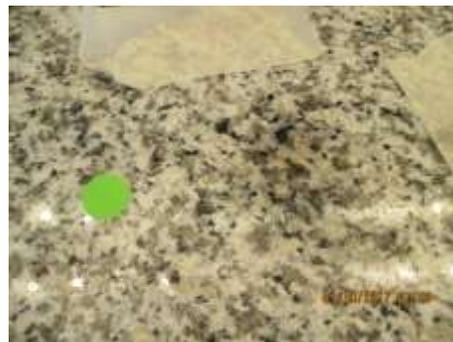
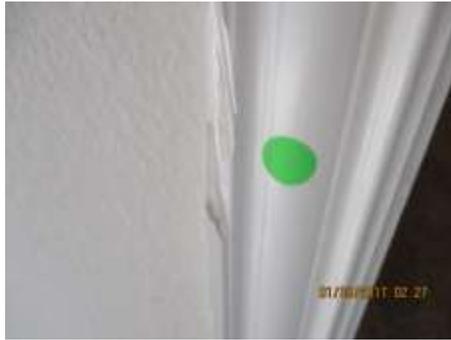
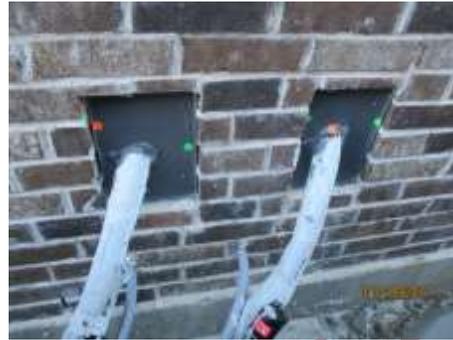
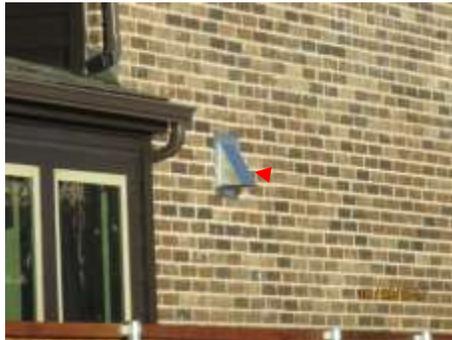
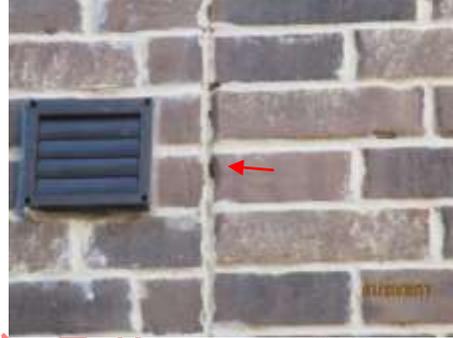
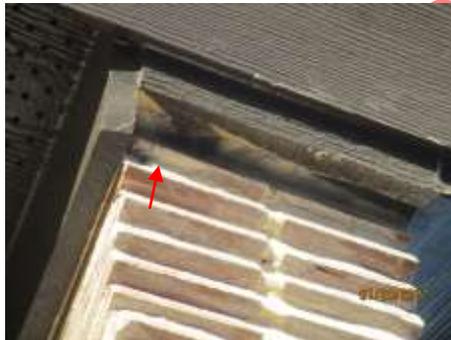
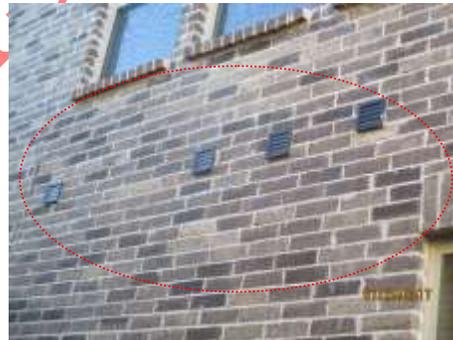
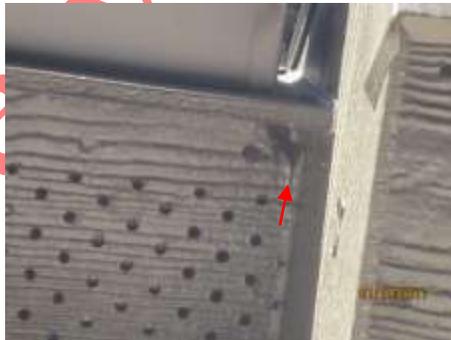
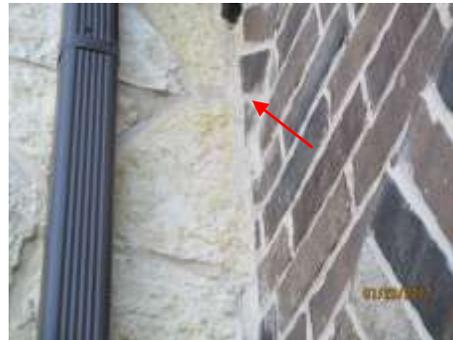
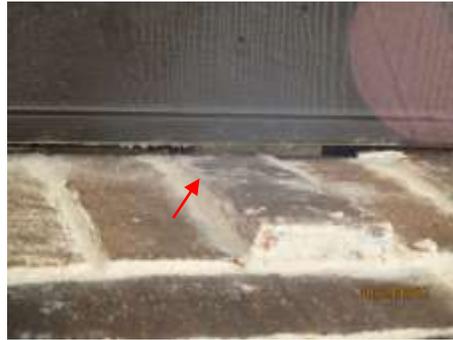
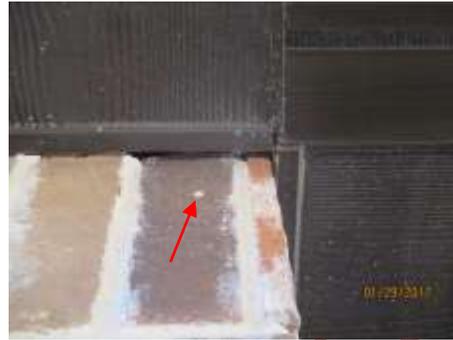
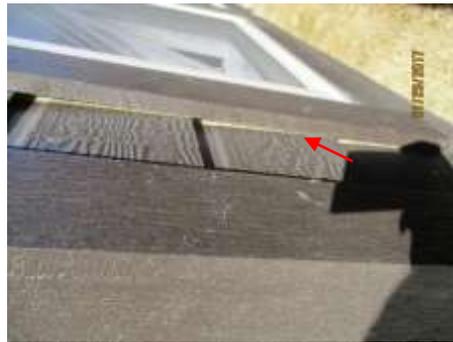
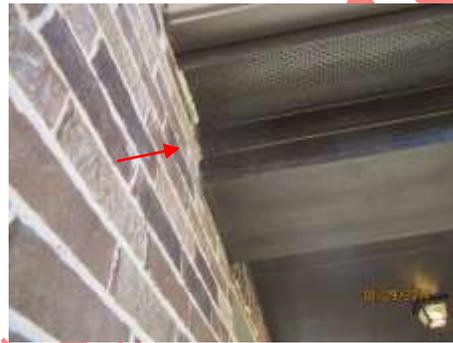
There is a triangular shaped hole in the upper walkout attic area where the water heaters are located.

Some cabinet doors need to be adjusted to operate properly and to have even gaps.

There are excessive openings present at the back exterior patio areas, see dots.

One upper level door frame is damaged, see dot.

There is a mortar crack visible at the left side of the garage. See dot.

The bottom of one piece of wood trim needs to be painted at the right front side of the structure.

The exterior wall vents are not installed level at the right side of the structure.

One of the exterior vents needs to be painted to prevent rust.

There appears to be mortar spots and/or overspray at the masonry above the garage area. It may be necessary to power wash or acid wash the brick to ensure that all of white spots are removed.

There is a small overcut area in the cabinet under the gas cooktop.

Caulk, paint, and/or texture repairs are needed at several interior and exterior walls. See dots.

Several areas of the interior cabinets need stain touch-ups.

There are rust colored areas present at the countertop at the master bathroom.

Some of the exterior walls have voids in the expansion joint fillers.

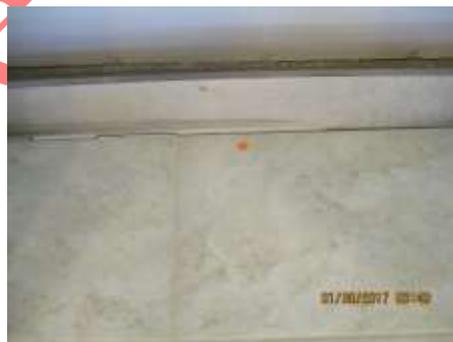
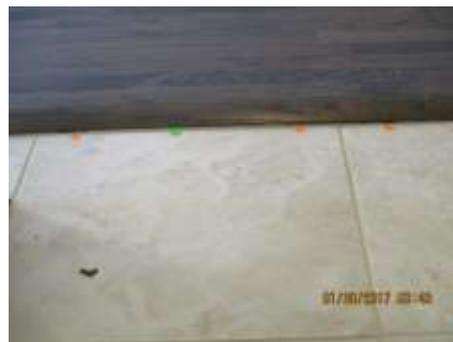
There is an open mortar joint present between the wood floor covering and kitchen tile areas.

There is an open mortar joint present at the floor where the refrigerator insert is located.

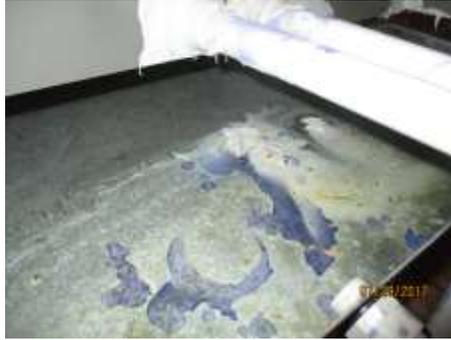
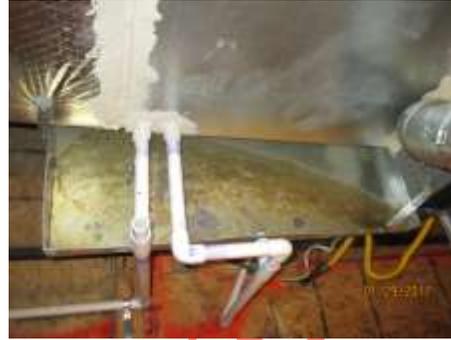
There are signs of previous water stains and/or debris present in both drain pans in the attic.

There are no flood stop switches present at either of the units in the attic.

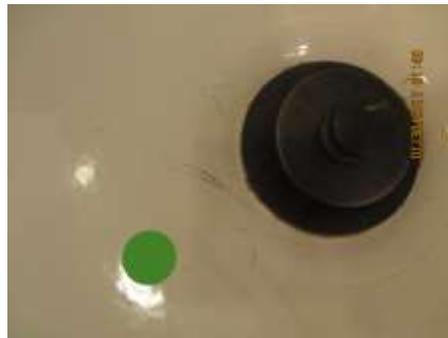
One of the upper bathroom sink fixtures is loose on the countertop, see dot.

Two of the tubs have surface scratches in them, see dot.

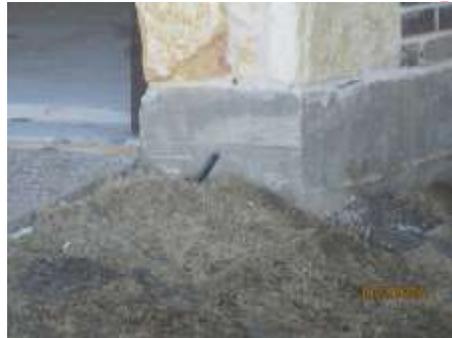
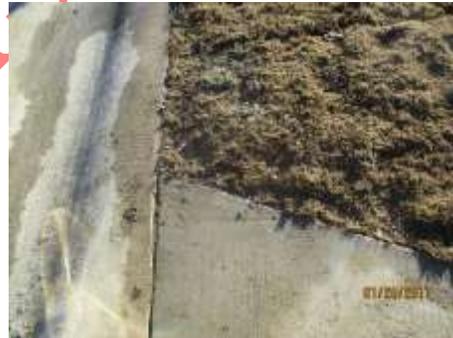
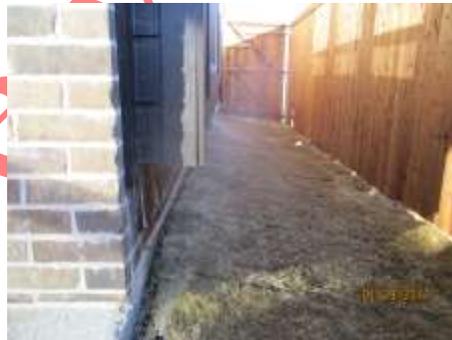
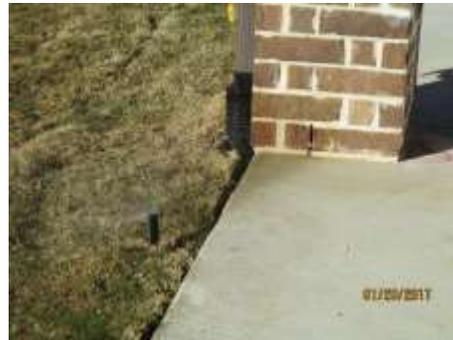
The drip lines at the front median leak when the water supply is off.

It is my recommendation that that irrigation system checked and repaired by the installation company to ensure that all deficiencies are properly repaired.
