PROPERTY INSPECTION REPORT

PURPOSE, LIMITATIONS AND INSPECTOR / CLIENT RESPONSIBILITIES

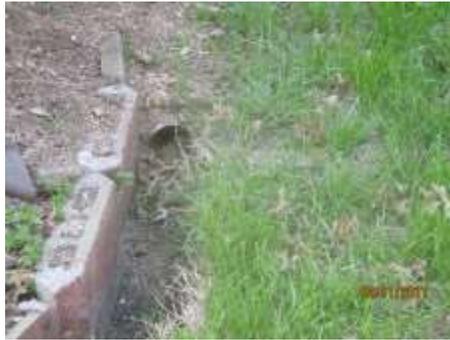
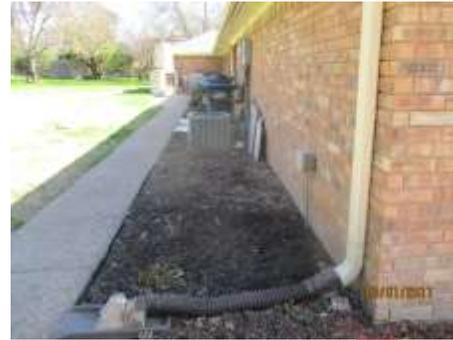
There are voids present under the exterior foundation wall at the front right side of the structure. It does not look as if the grade was properly packed down after the foundation repairs and someone has placed screen and bricks on top of the voids?

The soil line is too high around some areas of the foundation wall. Ideally you should have 2" to 4" of concrete visible at the foundation wall.

The drainage is relatively flat at all sides of the structure; the deficiency appears to be associated with age and recent foundation repairs.

One exterior drain is missing the cover grate at the back right side of the structure.

It is my recommendation that you obtain copies of the Engineers Reports, (pre and post repairs) the elevation readings (pre and post) and the Plumbers Static Test and Camera Test on the sewer lines to ensure that everything is in good working order.

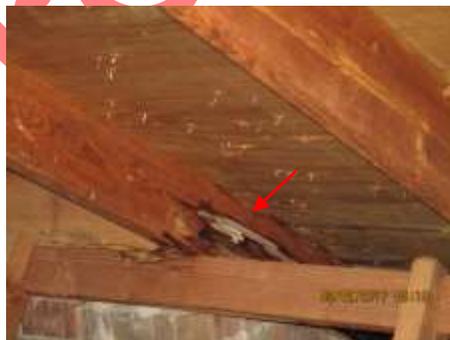
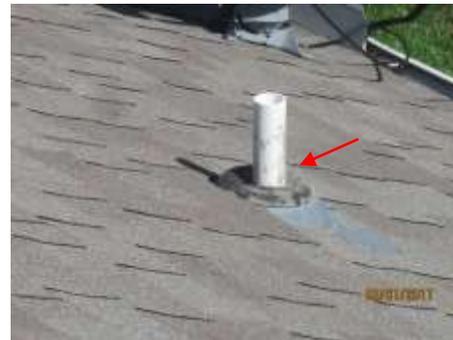
Some of the plumbing boots are concaved and holding water.

The flashing appears to be leaking around the chimney in the attic.

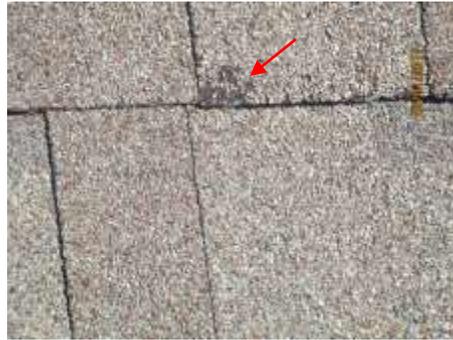
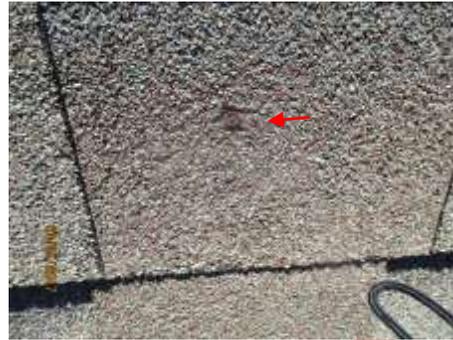
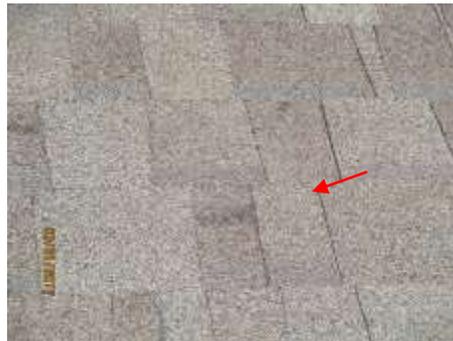
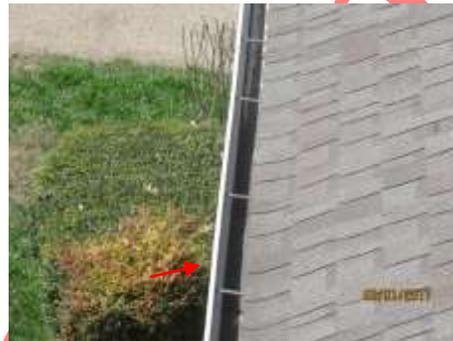
Observed signs of pests (rodents and/or birds) in attic (baits, nests, droppings, trails). Pests have been known to damage various attic components.

There are signs of water penetrations present at some decking areas. I am unable to determine if they are previous or an active leak.

There are some cracked rafters visible in the attic area. It is my recommendation that you have them looked at by to determine what repairs are needed.

There are signs of previous repairs visible at several areas of the framing members.

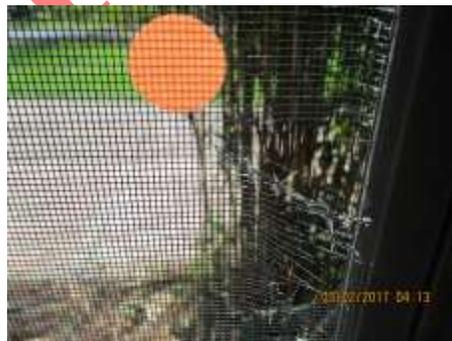
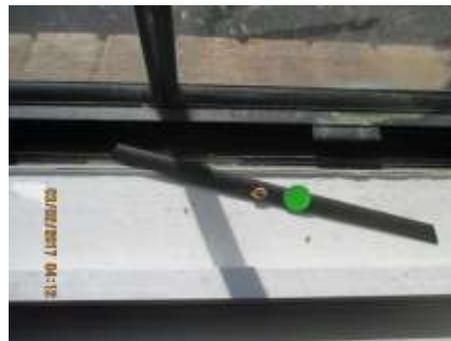
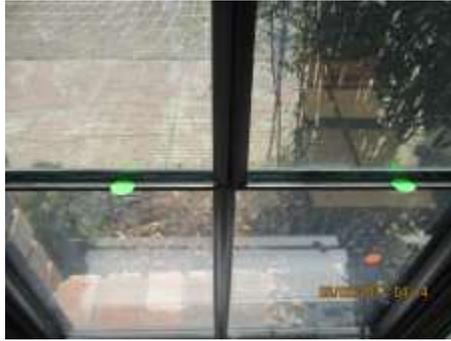
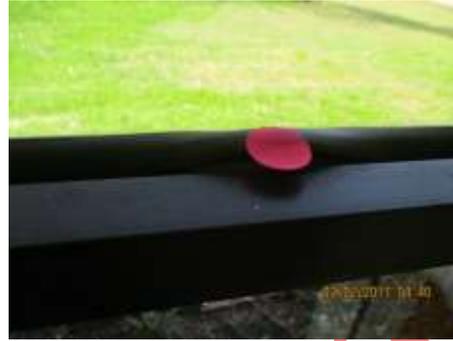
The exit doors have keyed deadbolts; these types of locks pose a concern for fire and/or safety hazards.

The weather stripping is deficient at some of the exit doors. See dots.

One glass pane is broken at one of the exit doors.

Some screens were missing and/or damaged.

Several of the windows have damaged frames, damaged plastic trim and/or other deficiencies associated with age.

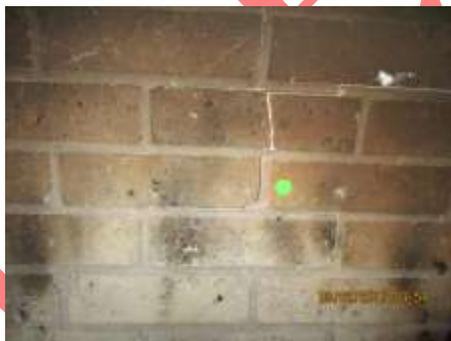
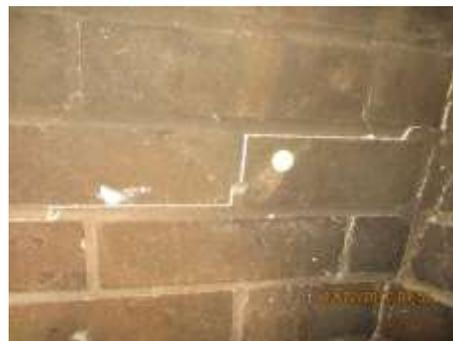
There cracks present at the back of the firebox that needs to be pointed up prior to use.

There is a screen on the rooftop but not a chimney cap.

The damper handle is broken off.

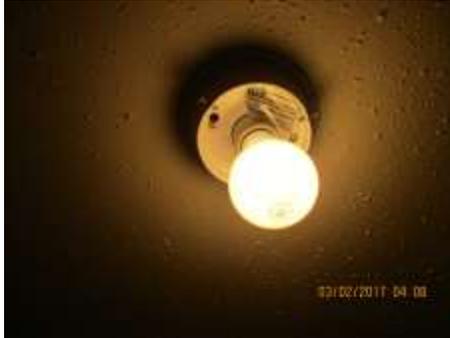
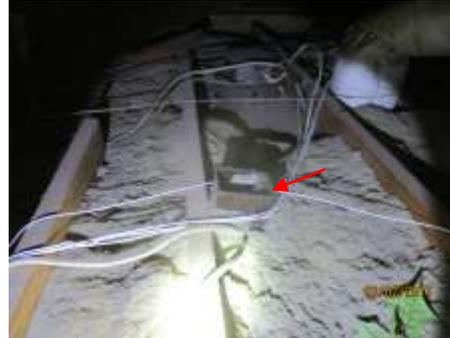
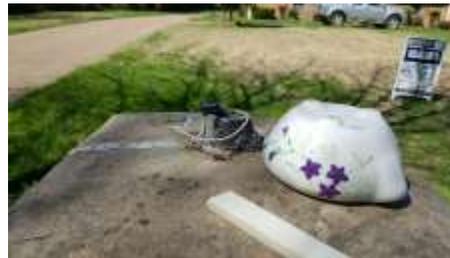
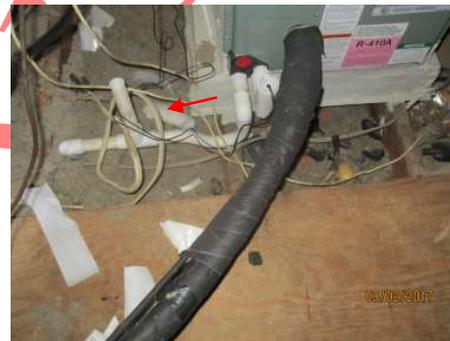
Not all of the recommended locations have you have GFCI protected receptacles which are now required for new construction. As of 2008, all garage receptacles should be GFCI protected.

Exterior receptacles are missing the weather tight protective covers that are now required for new construction.

Some of the interior receptacles are loose on the walls.

One of the post lights at the driveway is missing the fixture and has unprotected electrical wires.

Some fixtures are missing globes.

The GFCI at the kitchen does not trip with the tester. See dot.

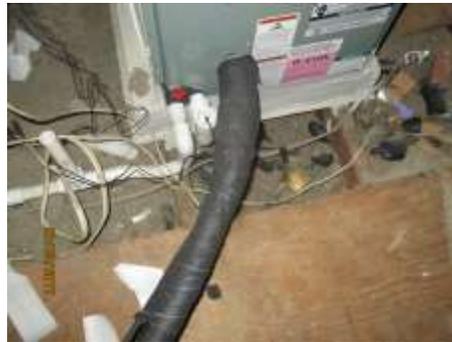
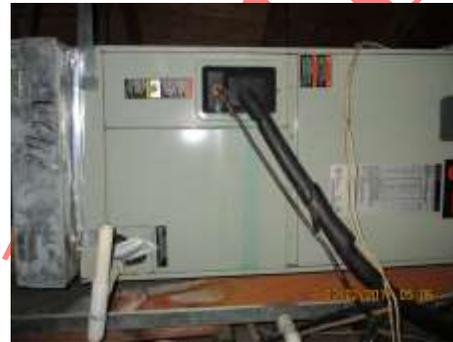
The master heating unit produces heating temperatures when the thermostat is placed in cooling mode.

It is my recommendation that a service call be performed on both HVAC units to ensure that they are in good working order.

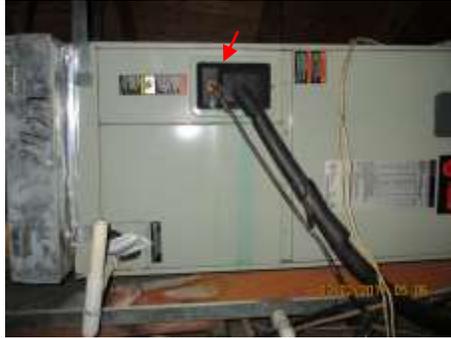
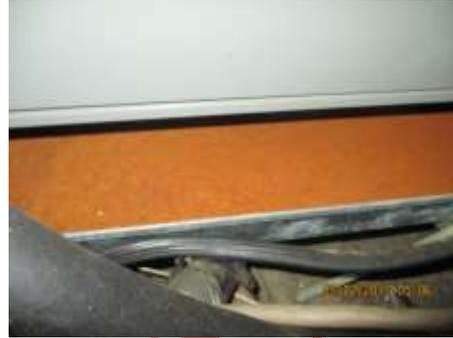
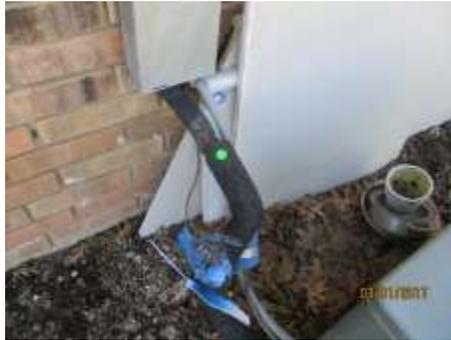
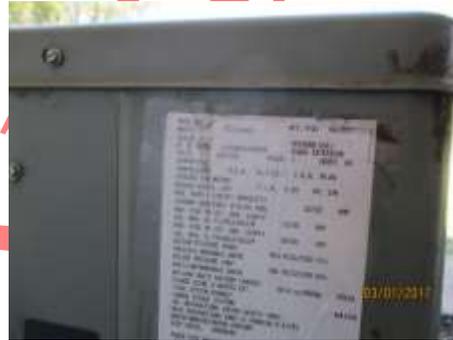
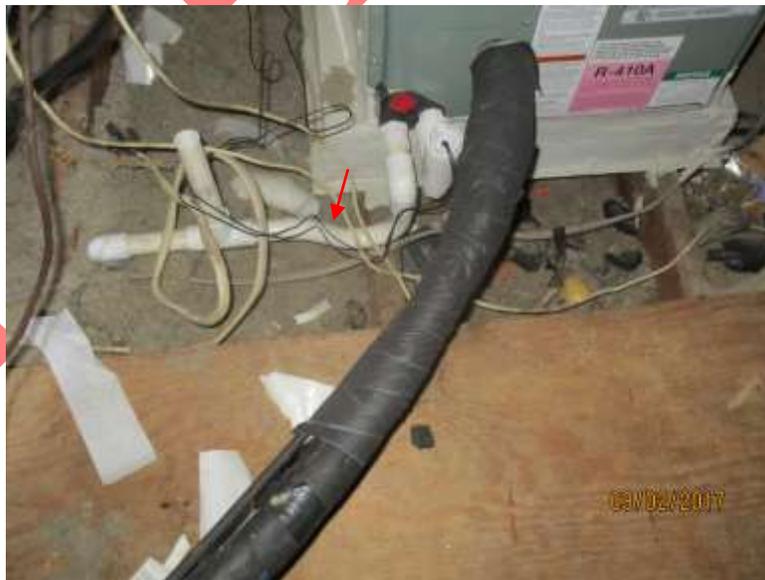
Both of the units are leaking cold air into the attic, where the lines enter the evaporator coils.

The master side cooling unit failed to produce temperature differentials that are within the acceptable range of 15 to 22° when placed in cooling mode.

There is a large amount of rust present in the drain pan at the master side unit and the unit produced heating temperatures when the thermostat was placed in cooling mode.

There are signs of water penetrations present under the vertical unit in the attic.

It is my recommendation that both of the systems cleaned and serviced by a qualified HVAC technician to ensure that they are operating as intended and to determine what repairs are needed.

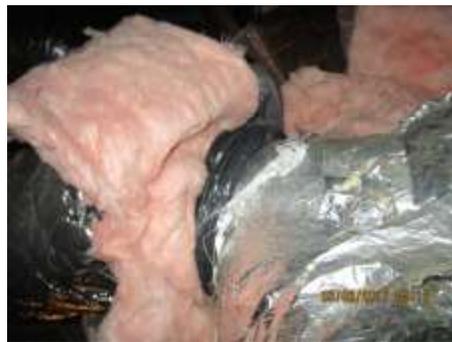
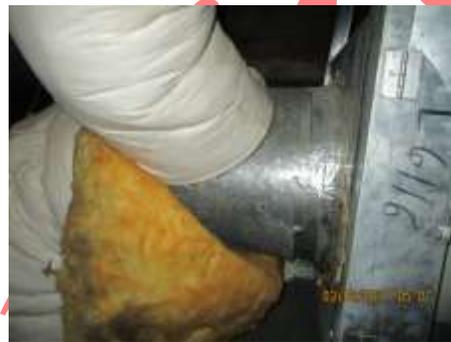
There is air leaking out of some of the ducts at the plenum of both units.

It is my recommendation that you have all of the ducts checked and repaired by a qualified HVAC Specialist.

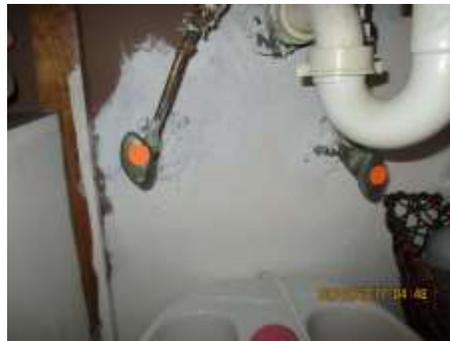
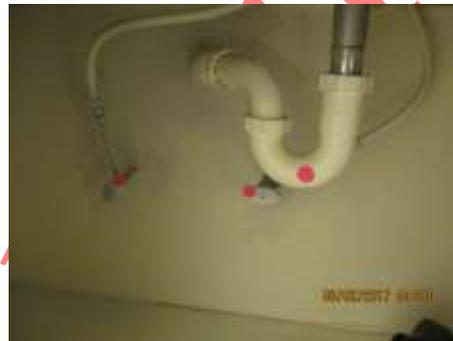
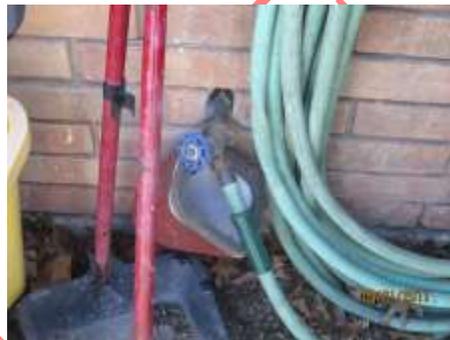
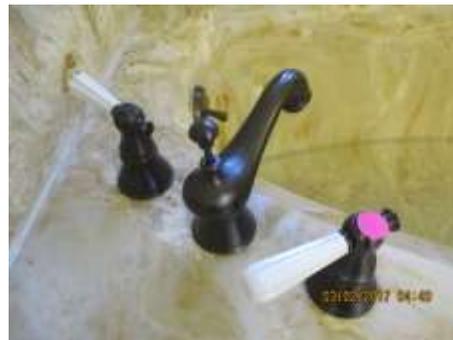
Some of the shower diverters leak when the shower heads are on. See dots.

One of the master tub water control knobs is stripped out and/or does not operate properly.

The exterior hose bibs need to be insulated and they are missing the anti-siphon device.

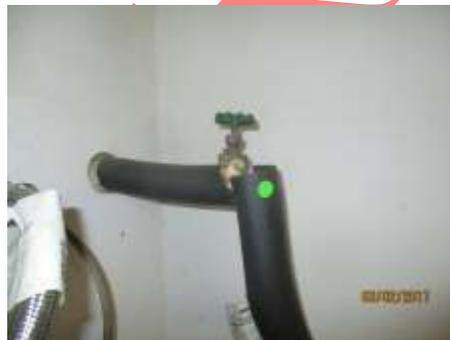
There is corrosion present at the top of the water heater at the garage unit.

The unit is not installed in a drain pan.

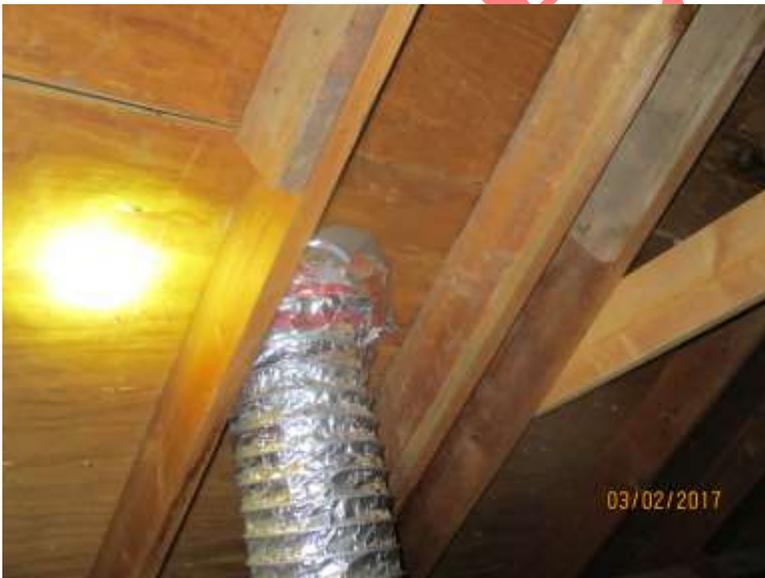
There is an improper material present for the kitchen exhaust fan and the unit is terminating into a wind turbine at the rooftop.
