“COMMERCIAL” DUE DILIGENCE INSPECTION REPORT

August 14, 2015

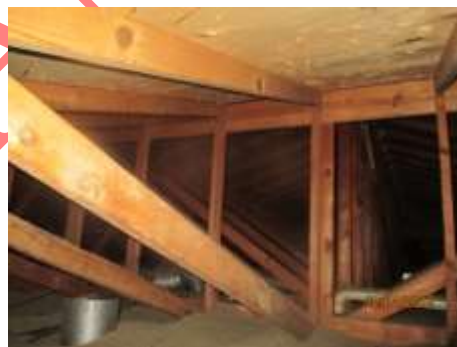
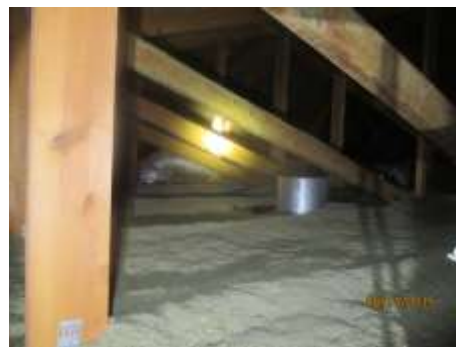
These buildings are constructed with a wood truss system with no deficiencies present at the interior attic areas that were accessible.

The firewall appears to be present at the accessible attic areas.
