PROPERTY INSPECTION REPORT

New Construction

I. STRUCTURAL SYSTEMS

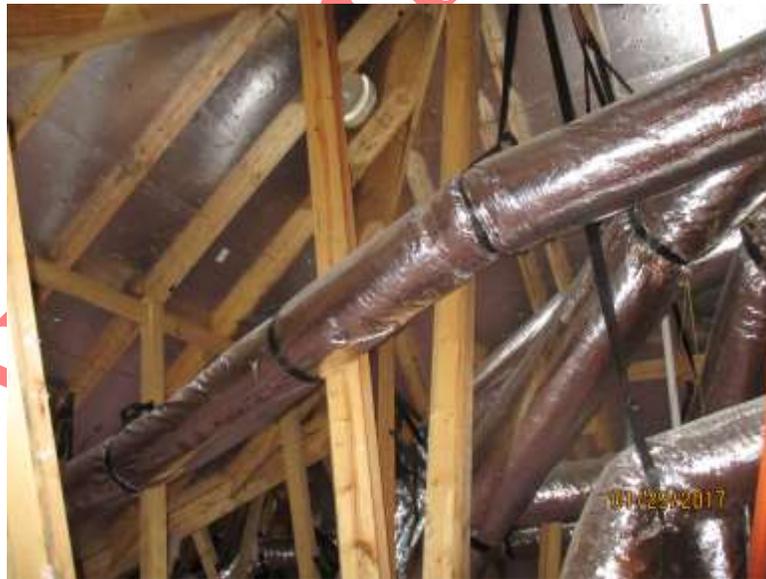
Consistent temperatures readings were produced at supply registers.

All of the A/C ducts are properly suspended to ensure consistent airflow

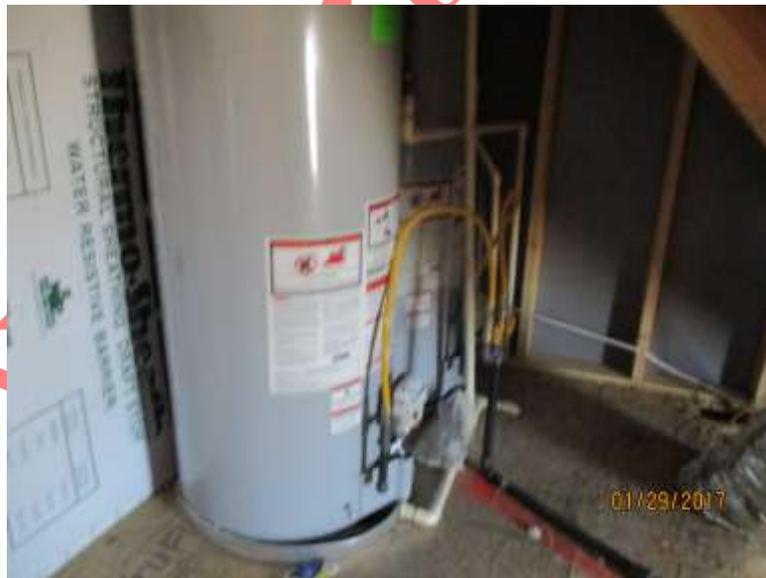
The lever on the Temperature and Pressure (known as T & P valve) relief valve(s) was not operated manually because of the possibility of damage to personal property.

The water heater(s) is operating and delivering hot water to all fixtures at this time.
